**BEFORE THE PUBLIC UTILITY COMMISSION
OF OREGON**

IN THE MATTER OF IDAHO POWER COMPANY'S, PETITION FOR CERTIFICATE OF PUBLIC CONVENIENCE AND NECESSITY.	Docket: PCN 5 Testimony Sam Myers
--	--

30 Year Severe Weather Recap

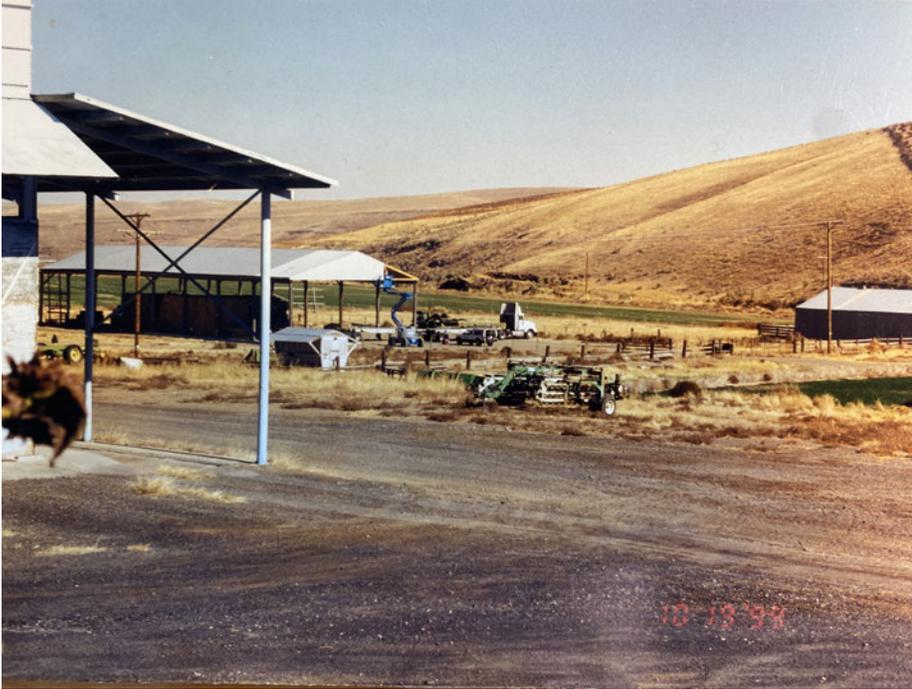
3. [March 2, 1999 - High Wind Event](#). During the spring of 1999 we had a wind event that blew off the roof of a building on our farm(see picture below). The contractor that was repairing this building commented that the winds reached 100mph+ based on the damage he saw.

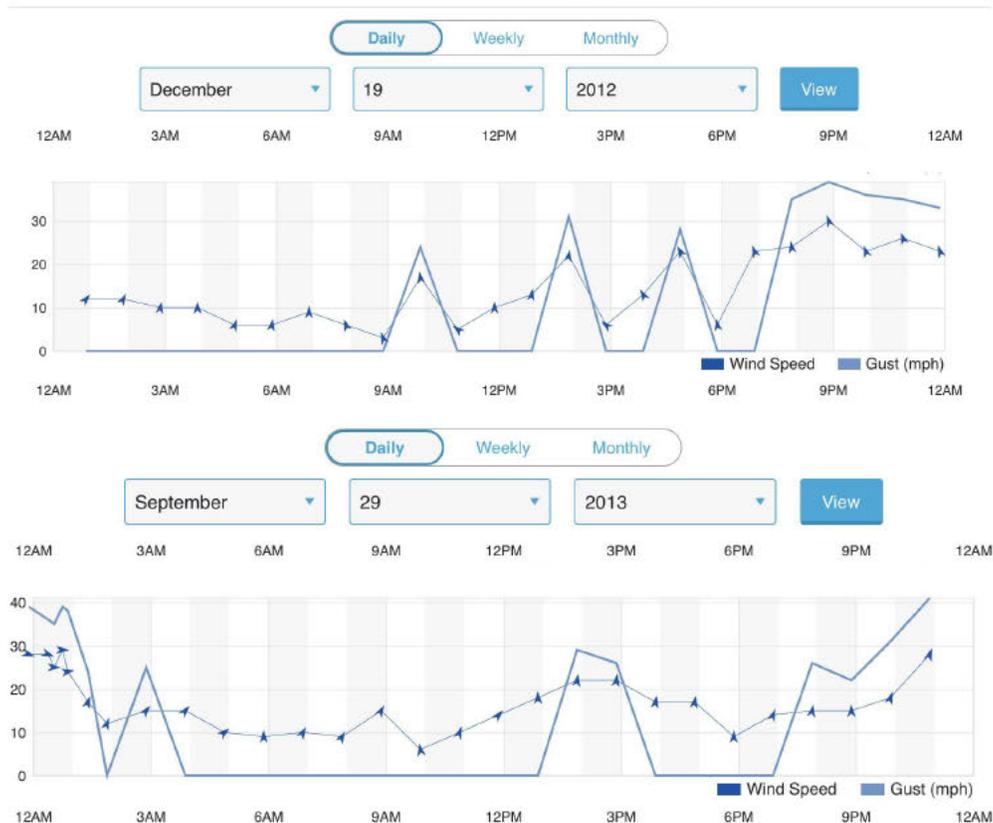
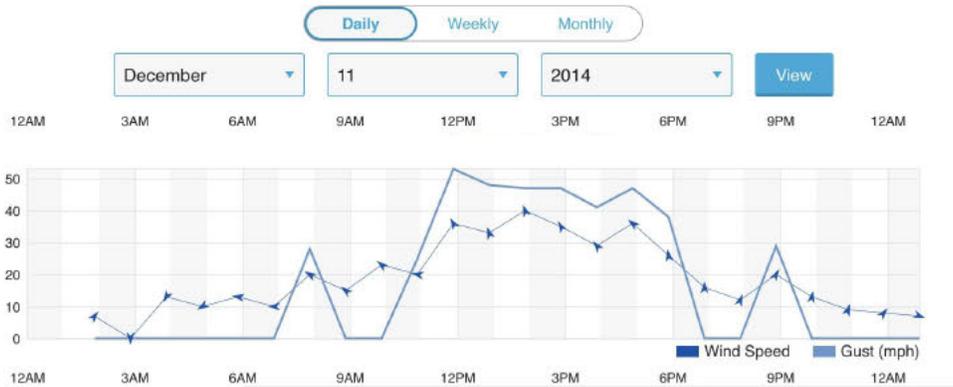
Morrow County Weather Variances

Looking at our recorded wind speed event dates and comparing those dates to winds recorded to Pendleton, Oregon's weather station(30 miles ENE from our location) you can see a stark difference between the two locations. For our most intense wind events you can see they don't experience the same intensity of wind speeds as experienced on our farm. On these occasions we are experiencing mostly double the wind speeds as the recorded speeds observed at the weather station. This confirms our first hand experience in dramatic fashion. IPC has not recognized this climatic phenomenon. The continued neglect of this data can produce deadly consequences to those in our community. Tower failure and catastrophic fires must be avoided at all costs. Collected from: <https://www.wunderground.com/weather/us/or/pendleton>
