Portland General Electric Company

Re: UE 196 - Boardman Deferral Amortization

- **ALJ Bench Request Rebuttal Testimony and Exhibits of Stephen Quennoz – PGE Exhibits 700 through 709. Portions of PGE Exhibit 700 are redacted and included under separate cover, pursuant to the protective order 07-433 in this docket. PGE Exhibit 702C is also confidential and subject to protective order 07-433 and sent under separate cover.**

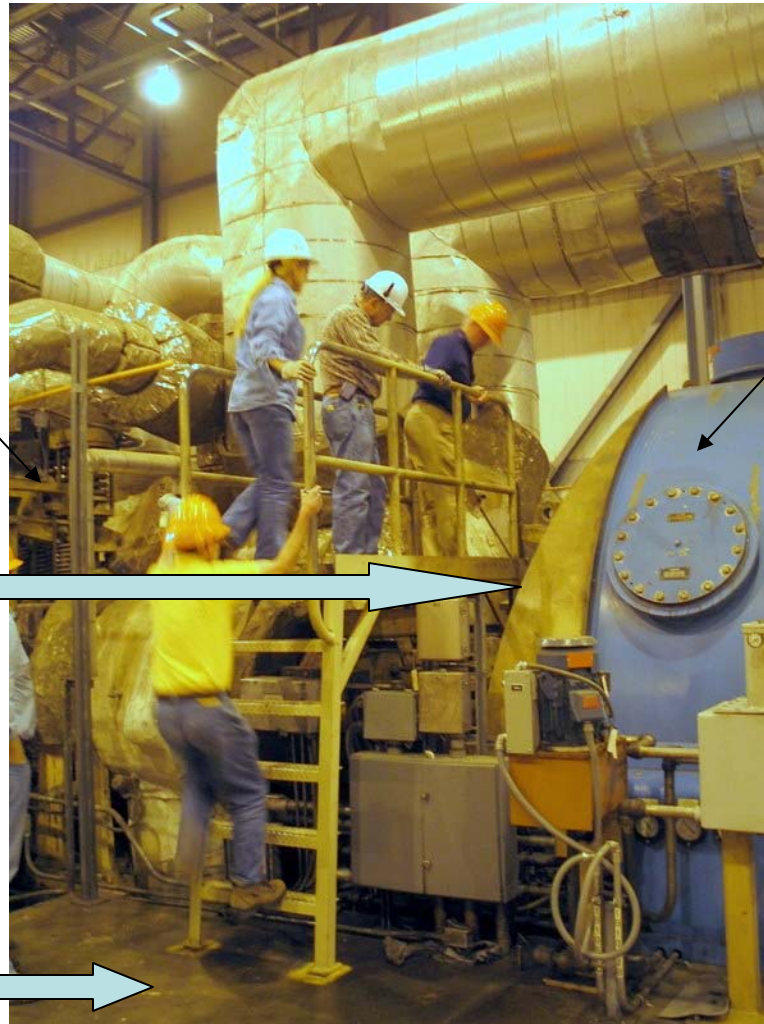
Area
Between
Turbines
Where
Photo of
Nut 25
Taken

Turbine
Operating
Deck

LP1
Turbine

Note: Nut 25 is
not visible from
the turbine
operating deck

11 During his site visit to Boardman, Mr. Martin photographed the base of the bearing 3
12 support, by climbing up on platforms between the HP/IP LP1 turbines and taking a
13 photograph with a flash into a dark recess below the deck. To get to the area where Mr.
14 Martin took the picture, it is necessary to first leave the turbine operating deck and climb a
15 ladder to access the area between high pressure and LP1 turbines. (See photograph in PGE
16 Exhibit 707). It is then necessary to step down between the turbines onto an area next to the
17 turbine shaft, look down past a gap in the steel, and peer into a recessed area where the nut
18 was located. This location cannot possibly be seen from the turbine operating deck. To give
19 an idea of where Mr. Martin is standing, and how he got there, we have attached a
20 photograph of Mr. Martin in the area where he took his picture. (See photograph in PGE
